Manhole Inspection Summary

Manhole # S13E1_006MH

Location Address: **1601 S. CATON**

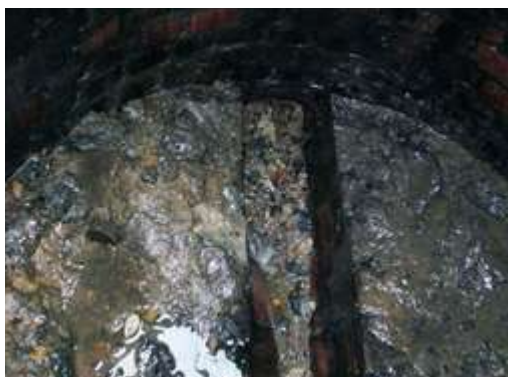
Miscellaneous

channel debris after draining manhole

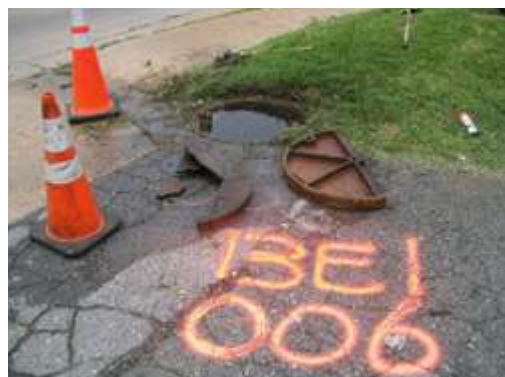
MISC. PAVEMENT MARKING

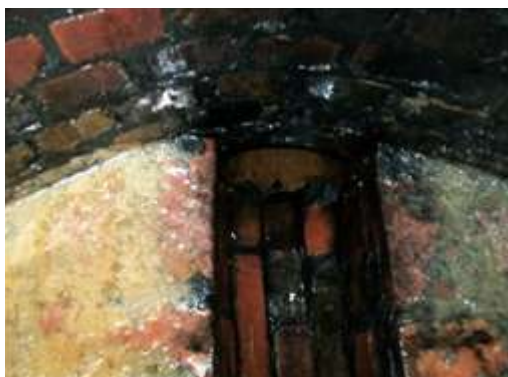
MISC. CHANNEL CLEANED

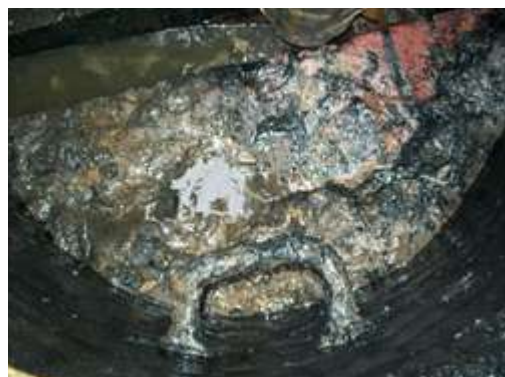
Defect 3

Steps Count: **1** Missing: **0** ☒ Corroded

corroded steps

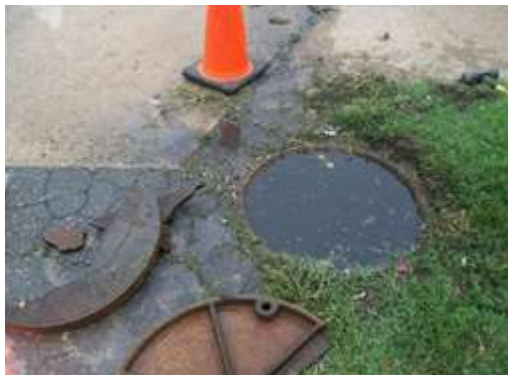
Defect 1

Surcharge ☒ Evidence Of Surcharge Depth: **5.5** (ft.) ☐ Active Surcharge Present

EVIDENCE OF SURCHARGE

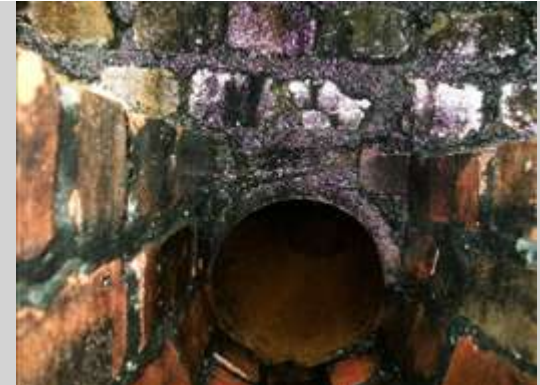
12 O'Clock Outflow

8 in. Circular Gravity Sewer
Pipe Out @ 12 O'Clock

Pipe Height: **8.4** (in.) Rod and Bar (Angled)
Pipe Material: **Clay** ☐ Pipe Lined
Invert Depth: **6.42** (ft.) Flow Characteristics: **None**
Deposits: ☒ None ☐ Mud ☐ Sludge ☐ **Debris** ☐ Grease
Silt Depth: **0** (in.) Deposits Extent:
Infiltration: **None** Pipe Seal Cond: **Sound**

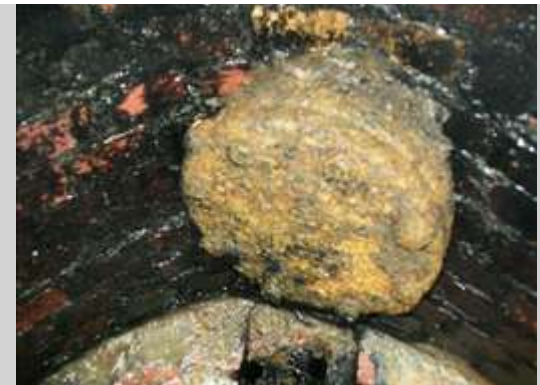
6 O'Clock Inflow

6 in. Circular Gravity Sewer
Pipe In @ 6 O'Clock

Pipe Height: **8.4** (in.) Rod and Bar (Angled)
Pipe Material: **Clay** ☐ Pipe Lined
Invert Depth: **4.67** (ft.) Flow Characteristics: **None**
Deposits: ☐ None ☐ Mud ☐ Sludge ☒ **Debris** ☐ Grease
Silt Depth: **2.5** (in.) Deposits Extent: **Medium**
Infiltration: **None** Pipe Seal Cond: **Sound**

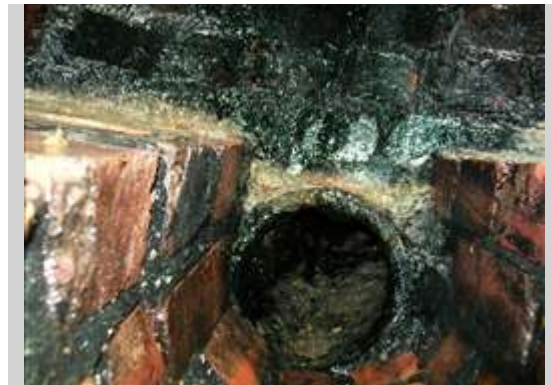
Drop In @ 6 O'Clock

CAPPED

Drop: **Outside** Rod and Bar
Angled: **Yes** Reading: **4.67** (ft.)
Inv Depth: **5.67** (ft.)

Drop Condition: **Clogged**
